## LOG CABIN NOTCHES

Lawrence J. Fleenor, Jr.  
Big Stone Gap, Virginia  
Oct. 25, 2015

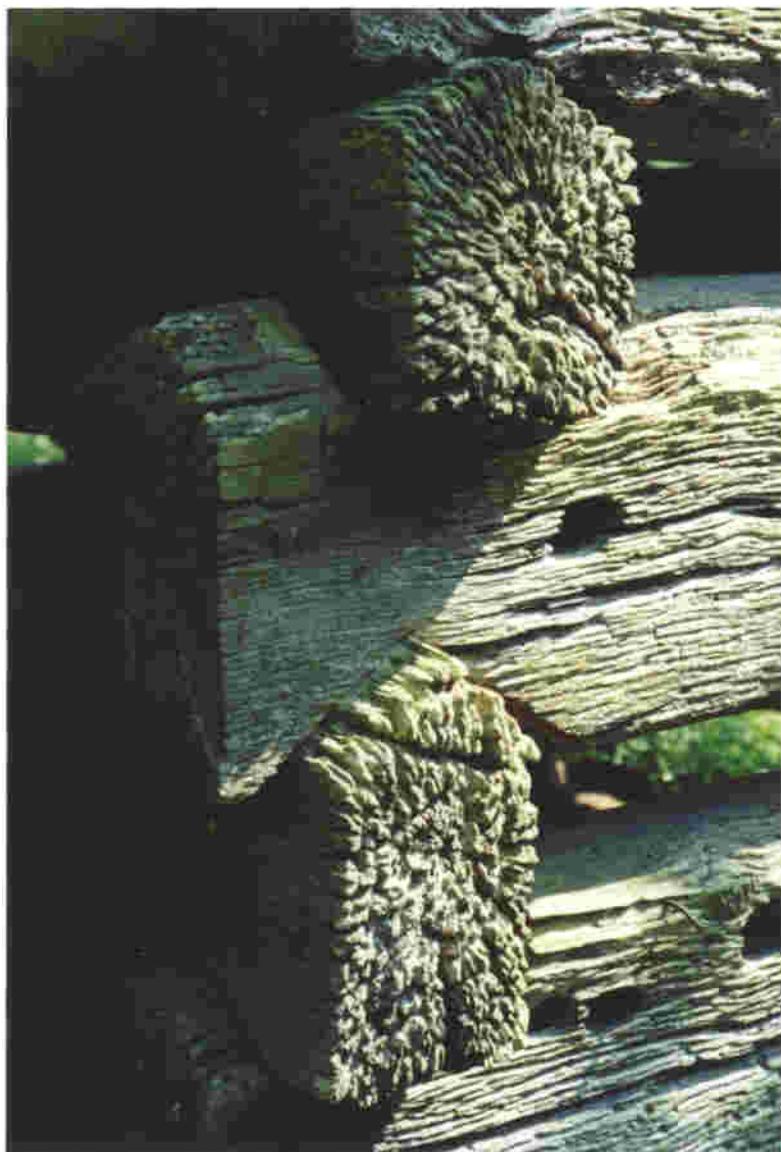
**V KNOTCH**

- 1) V notch – Attached is a photo of a V notch done on an out building, hence the limited attempt to bring the spacing between the logs closer together. It is standing on the left of the road that runs from Holston to Mongle Springs. I will make no attempt to improve on the description provided by the photo. The salient practical features are that it is unstable to outward forces, and can be pulled apart outwardly; and that it can be made with a broad ax with limited skills being necessary. It was the oldest notch used, and I do not know (knot no) the origins, but do know that the earliest Indians (the Xuala) in the area (Saltville) built log cabins. Perhaps we borrowed the design from them.

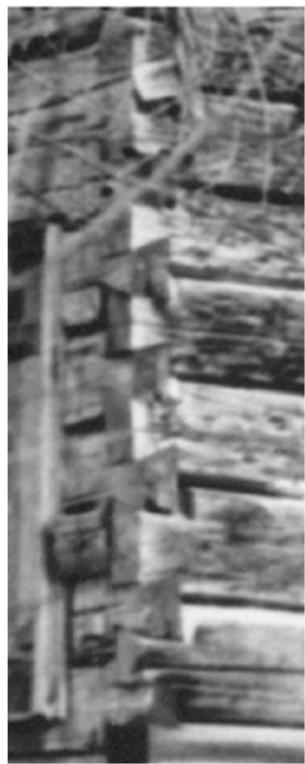
**HALF DOVE TAIL  
KNOTCH**

- 3) The half dove tail – About 1840-1850 the ‘better’ people began to move to brick homes, leaving the log cabins to the middle and lower classes. They got lazy, and

compromised on the trouble it took to make a full dove tail, and made the bottom of the joint a straight un sloped cut back. This joint required a lot less time and skill, and was stable enough for the less than perfectionist. This represented the first degeneration in log cabin construction. I would make a parallel with today. When I was a boy, a quality home would be built by a framing carpenter, who owned a 10 point saw and an eighteen ounce hammer. When he had the house framed, a finishing carpenter moved in, and he had a twelve point saw and a twelve ounce hammer. By the time I was grown, the finishing carpenter was gone and forgotten, and the framing carpenter did it all.
